PENSACOLA, FLORIDA

The Deepwater Horizon
Oil Spill Trustees

JULY 18, 2016

Phase III: Early Restoration Pensacola Bay Living Shoreline Project

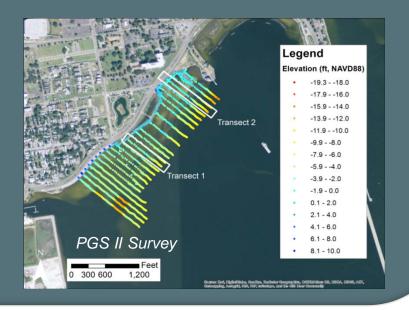
- Bathymetric survey data
 - Sanders bay bottom approx. -2 ft to 4 ft NAVD before sloping into bay
 - PGS II includes previously constructed submerged widecrested breakwaters

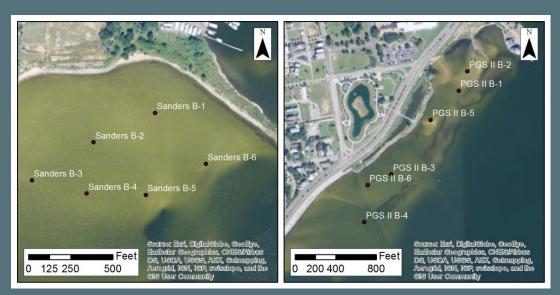
Geotechnical Boring Locations

- Assessment of subsurface material, slope stability and bearing capacity, and settlement potential
- Sanders Beach fine, poorly graded sands to depths 10' to 18'
- PGS II fine to medium, poorly graded sand with some sand and silt throughout

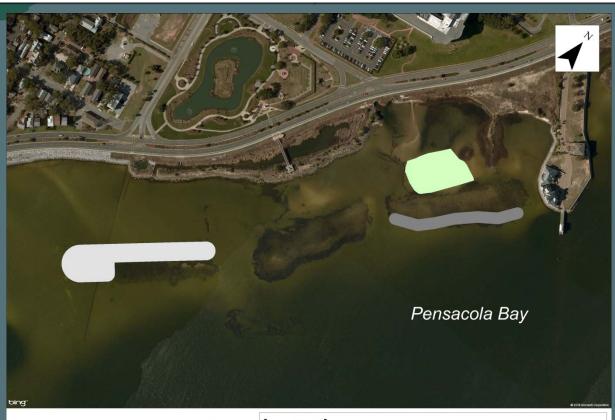
Project GreenShores Site II
Preliminary Layout

Breakwater (645 Linear Feet, 0.8 Acres)

Low-Crested Breakwater (725 Linear Feet, 1.9 Acres)

Salt Marsh Habitat (1.1 Acres)

- Evaluated project goals, site characteristics, current uses, and public comments received from Phase III process.
- Utilized surveys, investigations, and wind and wave information to develop the preliminary design.
- Assessed requirements for breakwater performance, materials, and dimensions.
- Evaluated performance of existing reef structures.
- Assessed requirements for healthy marsh habitat—layout provides suitable elevation and water flow within marsh.
